**THE STREAMBANK EROSION CONTROL
EVALUATION AND DEMONSTRATION ACT OF 1974
SECTION 32, PUBLIC LAW 93-251**

Appendix H - Evaluation of Existing Projects Volume 2 of 2

APPENDIX H EVALUATION OF EXISTING PROJECTS VOLUME 2 OF 2

Consisting of
A BRIEF SUMMARY REPORT AND INDIVIDUAL EVALUATION
REPORTS ON FIFTY EXISTING STREAMBANK EROSION CONTROL
PROJECTS CONSTRUCTED PRIOR TO OR SEPARATE FROM THE
SECTION 32 PROGRAM

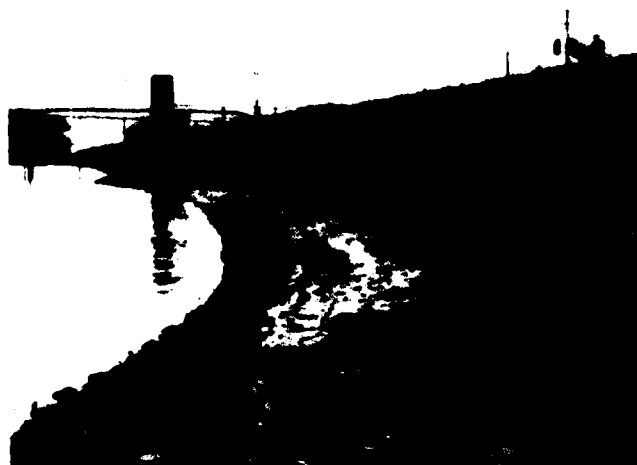
ITEM 29-3

**JUNE 1976 - LOOKING DOWNSTREAM. PHOTO SHOWS
SEVERE WAVE WASH AND SCOUR
DAMAGES TO EXISTING LEVEE.**

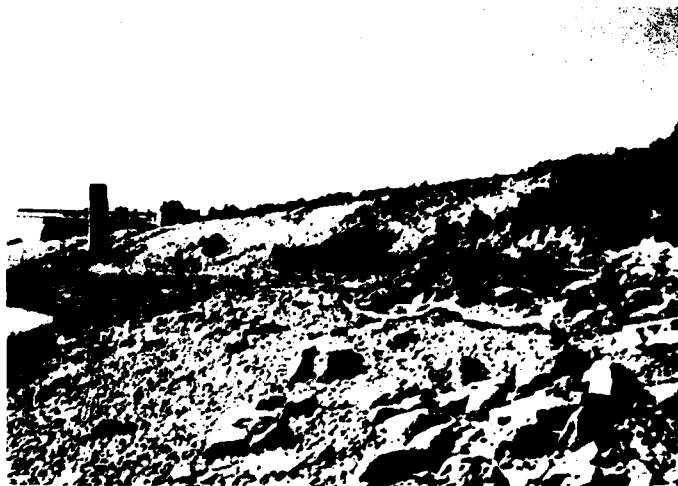
**OCT. 1980 - LOOKING DOWNSTREAM POST
CONSTRUCTION. PHOTO SHOWS
LEVEE SLOPE AND RIPRAP
ARE IN GOOD CONDITION.**

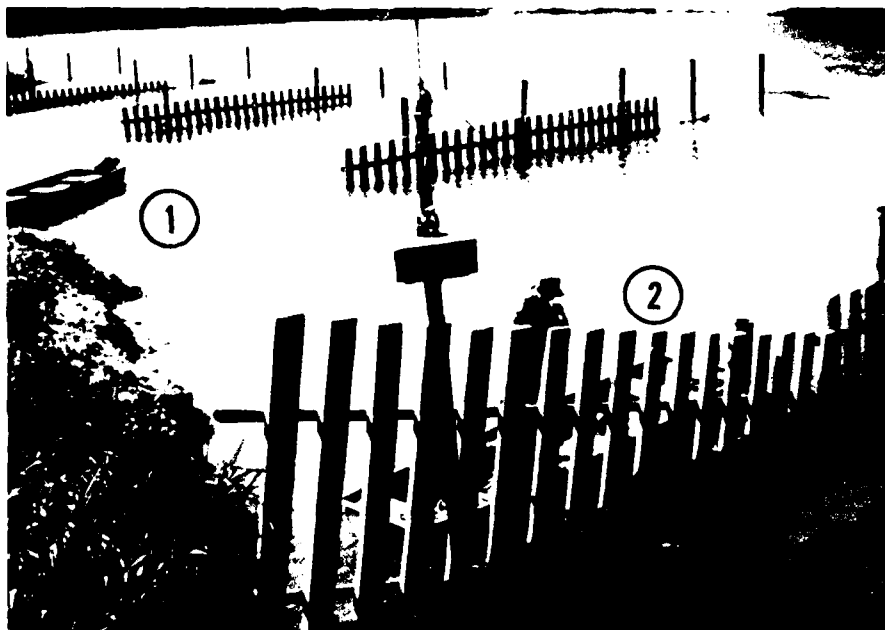
Repairs and Costs (Item, Cost, Date) In May 76 about 20 to 30 ft. of the bank
between the land side of the jetty and the riverbank was eroded. The
repairs amounted to adding another panel to the jetty. Maintenance is
the responsibility of private interests (pipelines company).

May 1976 - Looking downstream at timbers during repairs.
Photo shows erosion¹ and placement of additional panel²

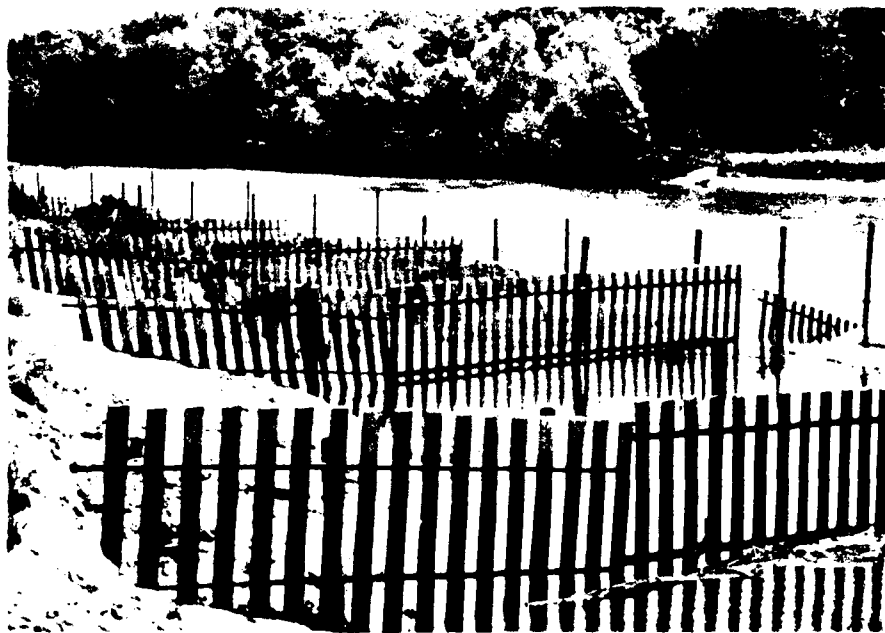
Sept 1976 - Looking downstream at timber jetties after repairs

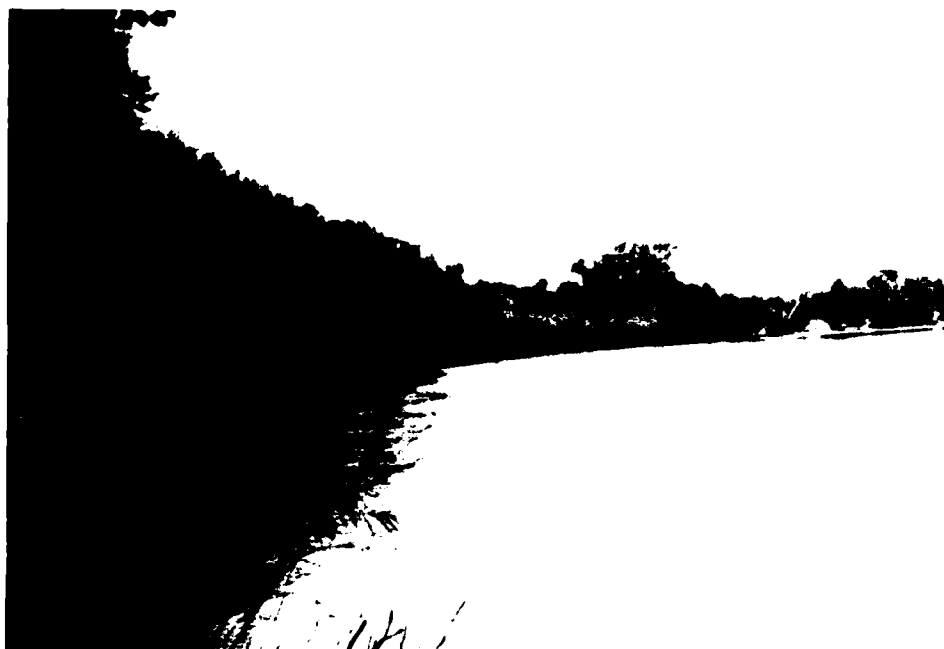
Photo 8

Taken 27 July 1979 looking upstream from creek inlet. Shows heavy growth of vegetation which has become established because placement of rock has prevented bank failure.

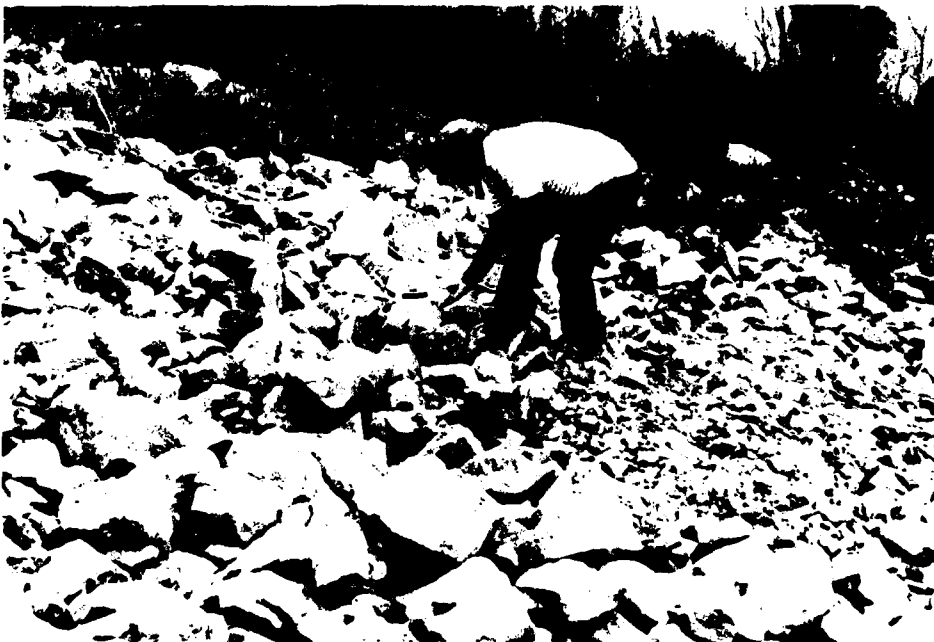
Photo 6
Left bank. Note small stone washed out of riprap by surface runoff. The cause is believed to be insufficient fines in the mass. The small material appears to generally wash from the mass down to the subgrade and be carried in small channels under the rock until it becomes blocked. It then washed out through the open texture of the mass. The clusters of small material generally show up below these channels which show a lack of fines.

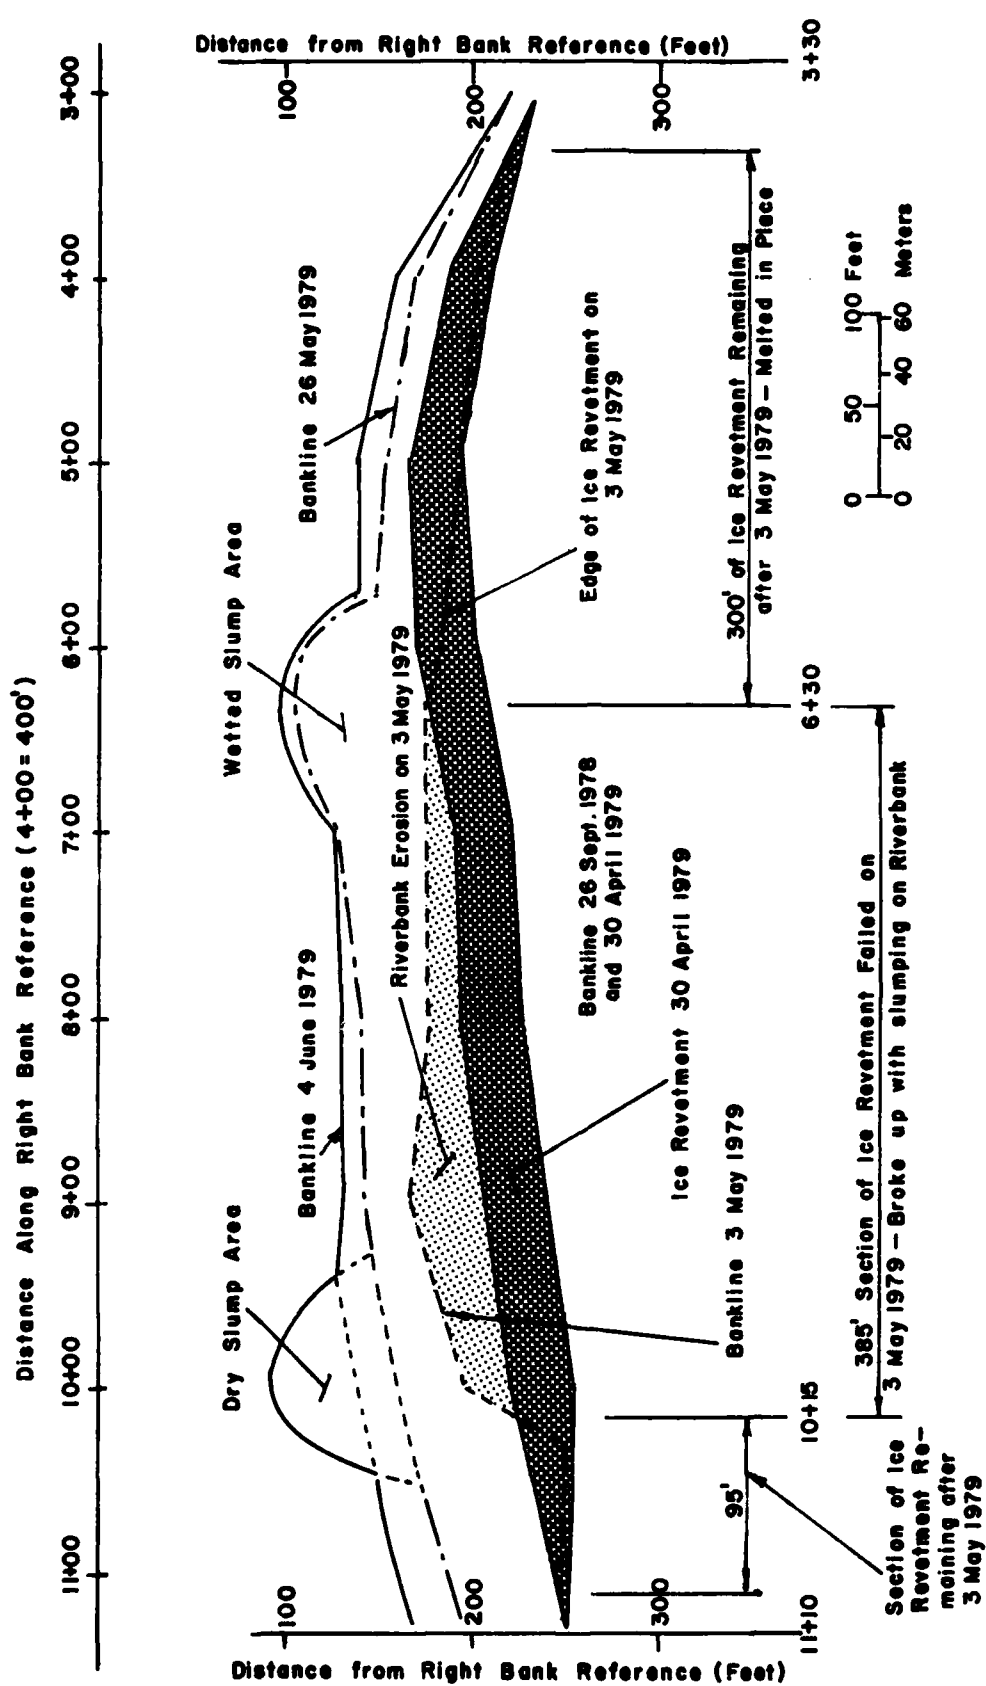
ITEM 34b-3

FIGURE 2 BANK-LINE SURVEYS SHOWING ICE REVETMENT FAILURE.

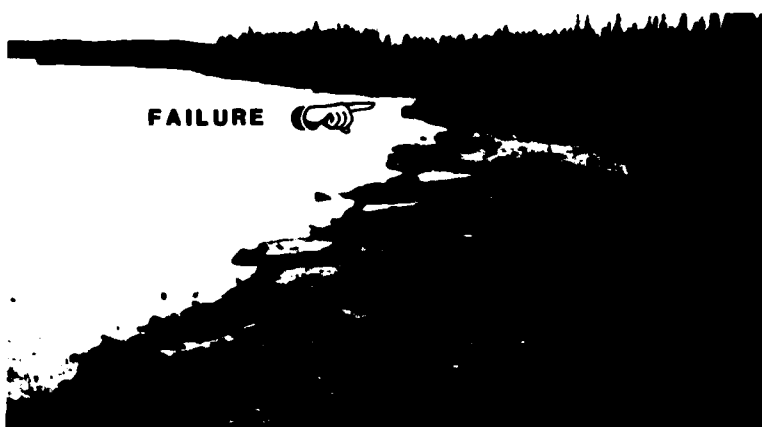
Photo 7 3 May 1979, river discharge is 47,000 cfs, ice revetment failure shown on downstream end, revetment still intact on upstream end

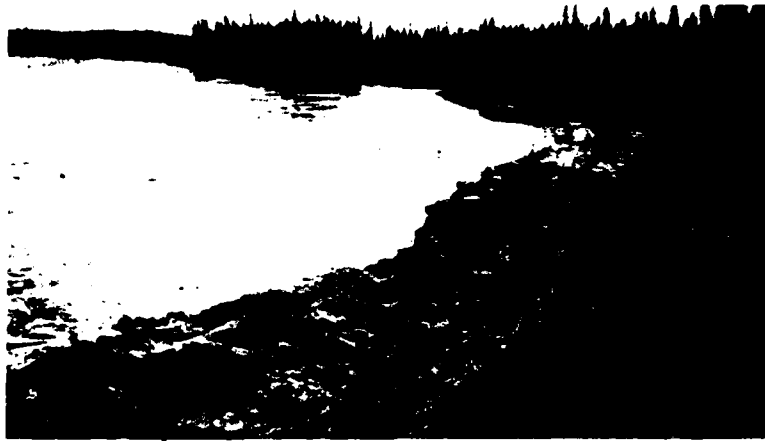
Photo 8 5 May 1979, discharge is 55,000 cfs, slumping and erosion of riverbank on downstream end, ice revetment still in place on upstream end.

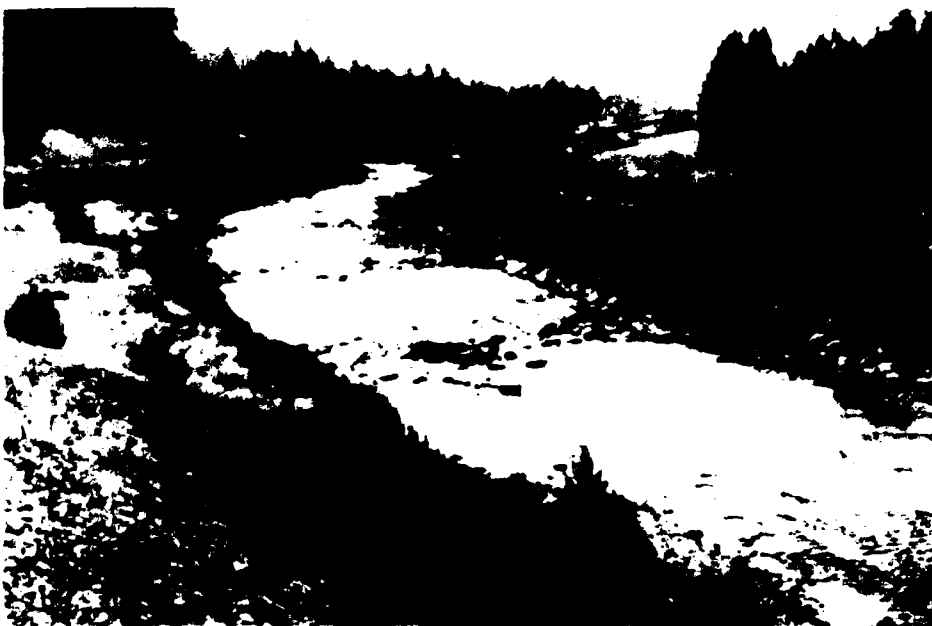
b. The groins were still recognizable on the date of the WES inspection visit (8 Aug 79); however, the rock was widely scattered

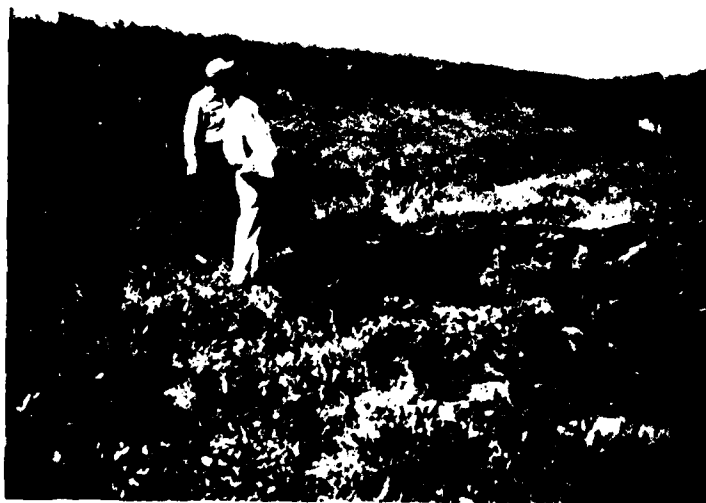
ITEM 39-2

White River, Levee Unit
8 at Edwardsport, Ind.
An inspection conducted
by ORL on 9 May 1973 in-
dicated that the berm
riverward of the left
bank levee had been
eroded to within 2 ft
of the toe.
